Manhole Inspection Summary

Manhole # S17CC1012MH

Location Address: **3750 GREENSPRING AVE**

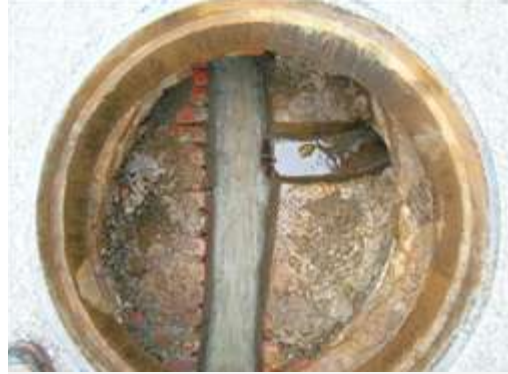
Top View

Evidence of surcharge - Bench debris.

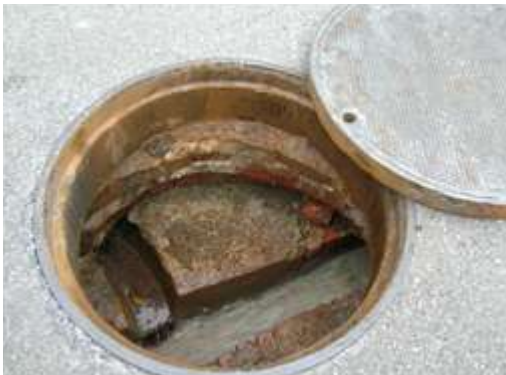
Defect

Frame leaks. Frame offset. Adjustment, Barrel, Bench and Channel deterioration. Adjustment and Barrel infiltration - other

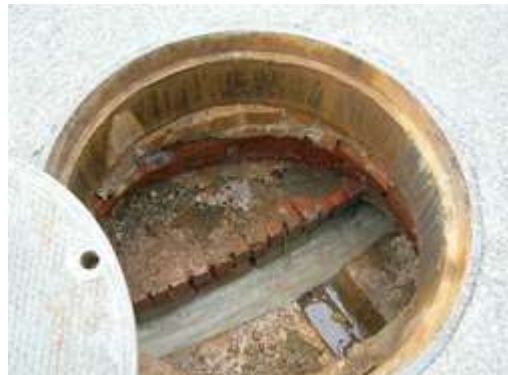
Defect

Frame leaks. Frame offset. Adjustment, Barrel, Bench and Channel deterioration. Adjustment and Barrel infiltration.

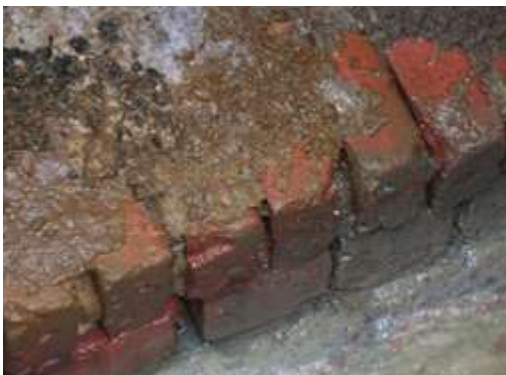
Defect

Bench and Channel deterioration.

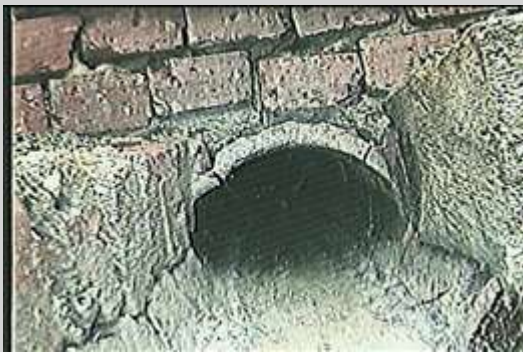
8 in. Circular Gravity Sewer Pipe Out @ 12 O'Clock

Barrel deterioration and infiltration. Channel deterioration.

Infiltration: **Evidence** Pipe Seal Cond: **Cracked**

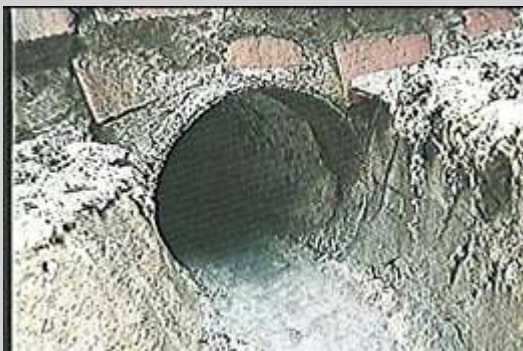
8 in. Circular Gravity Sewer Pipe In @ 2 O'Clock

Infiltration: **Evidence** Pipe Seal Cond: **Unknown**

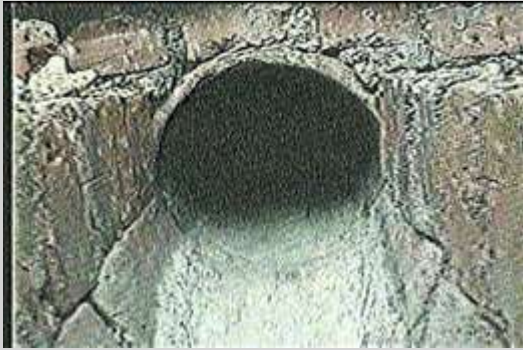
Pipe In @ 6 O'Clock

Barrel deterioration and infiltration. Channel deterioration.

Infiltration: **Evidence** Pipe Seal Cond: **Unknown**
